2007-2011 Toyota Camry Sun Visor Replacement

This guide will explain how to remove the lever arm from the sun visor, repair, and reinstall for a Toyota Camry back to functioning condition.

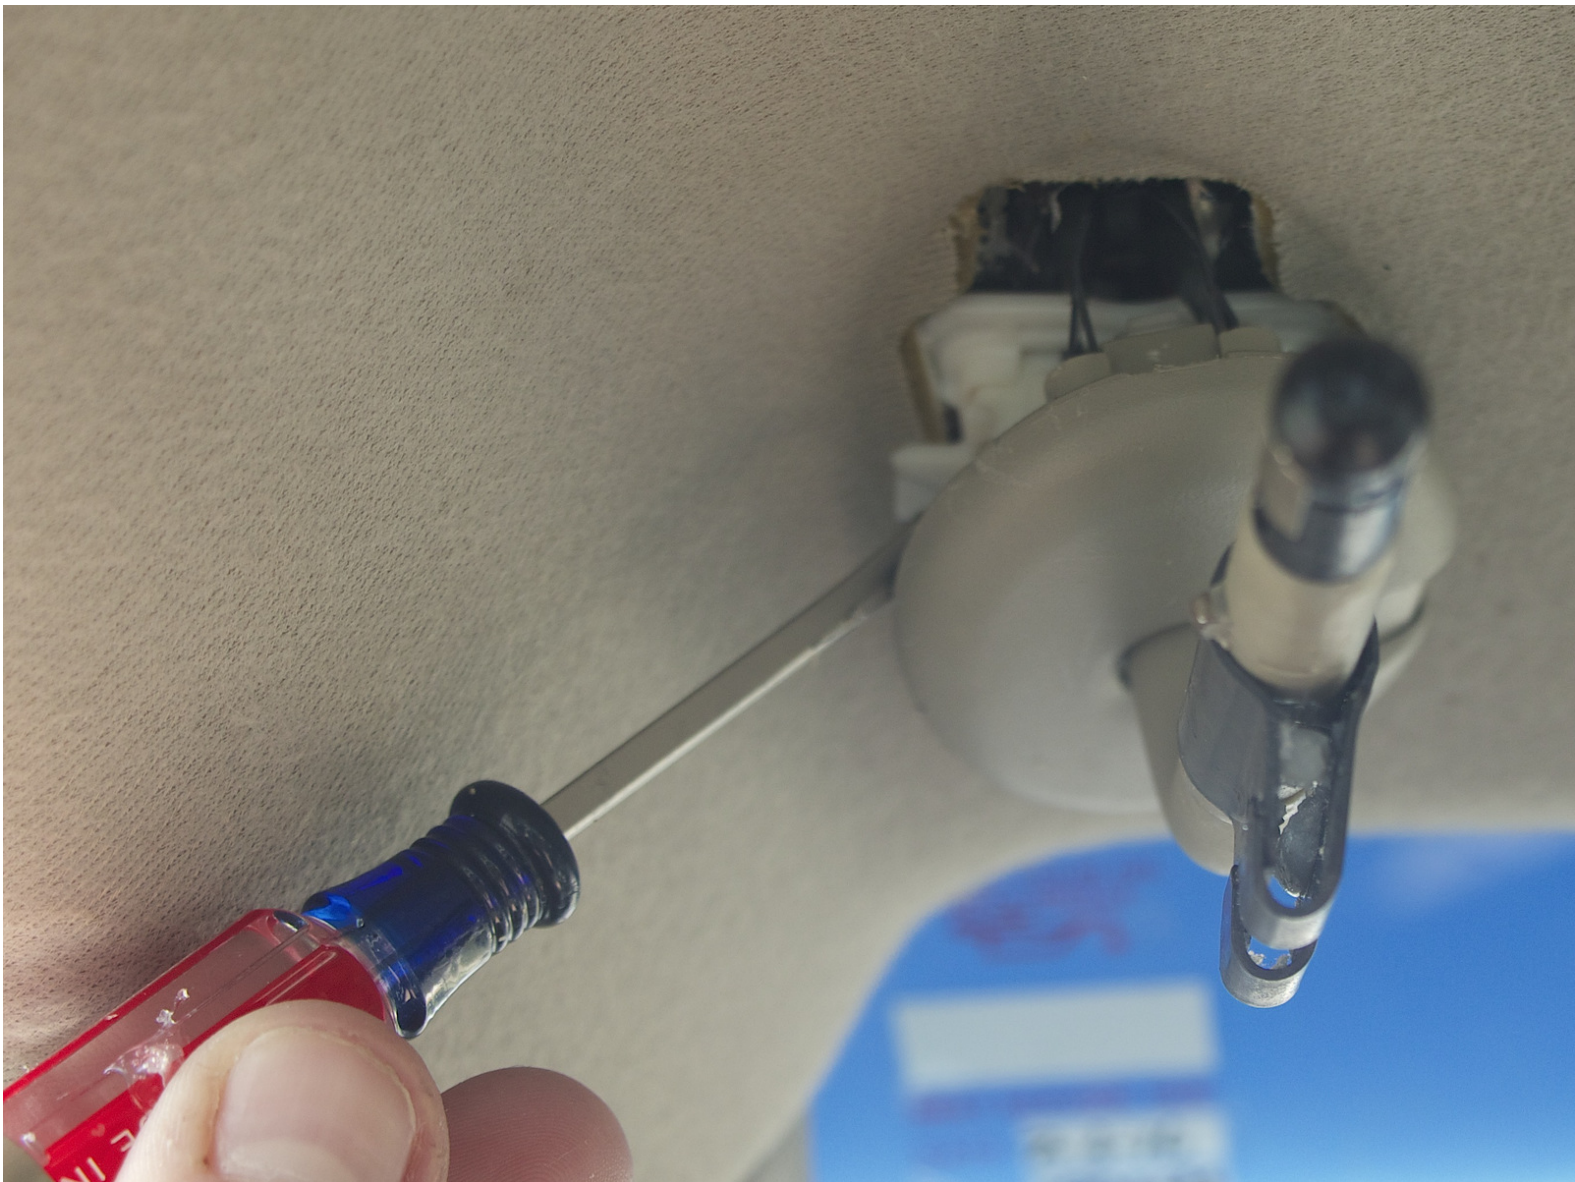
2007-2011 Toyota Camry's were installed with a sun visor that was later recalled due to a defect in the inner plastic body. The two halves of the visor that connect around the lever arm begin to pull away from the arm that attaches it to the interior of the car. Making the arm unable to hold the visor in place effectively, increasing the risk of it obstructing the view of the driver. Over time most visors even fall off the connecting arm completely. This guide provides a simple fix to the defect, providing a way to reinforce the faulty connection that is causing the problem. Follow our guide with the step-by-step process to insure that it will be fixed correctly.

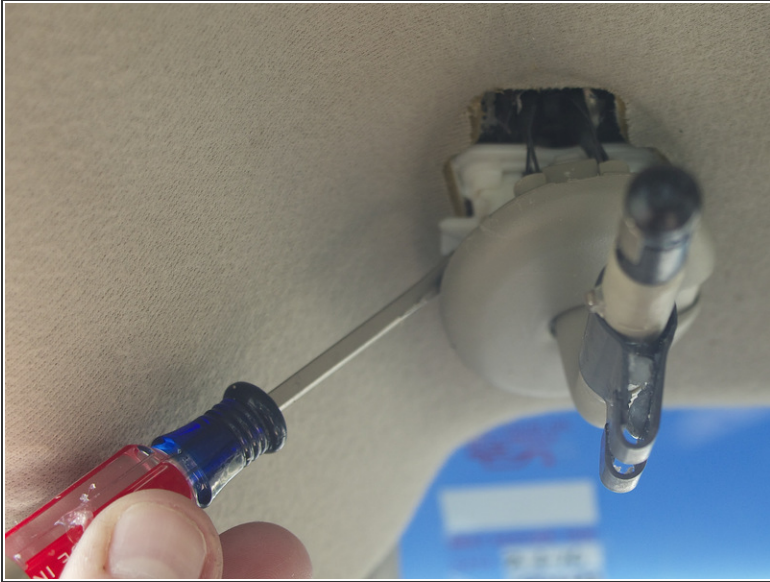
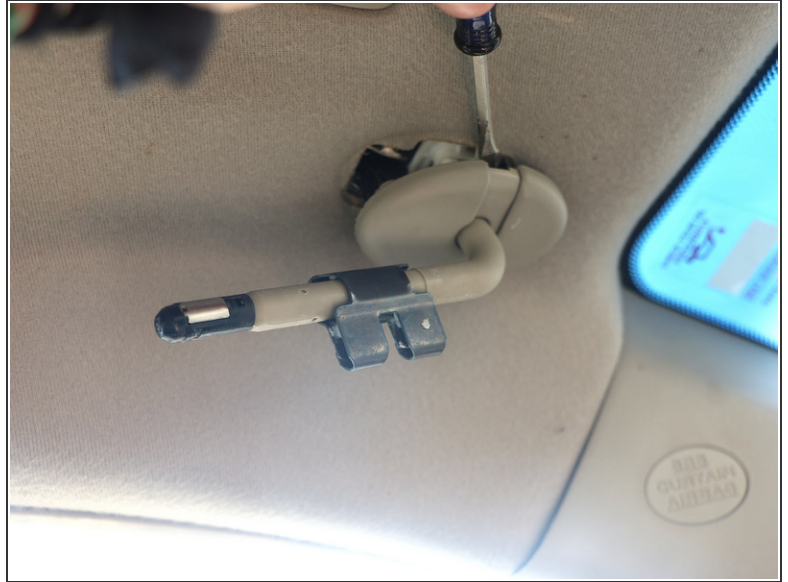
Step 1 — Sun Visor

- Loosen and remove the swing arm with flathead screwdriver and remove from interior of car.
- ⓘ Make a note of where the clips of the lever arm fit into the interior of car for reinstatement of the visor later.

i If you go back to step one, the hinges are marked to show where the insert the swing arm.

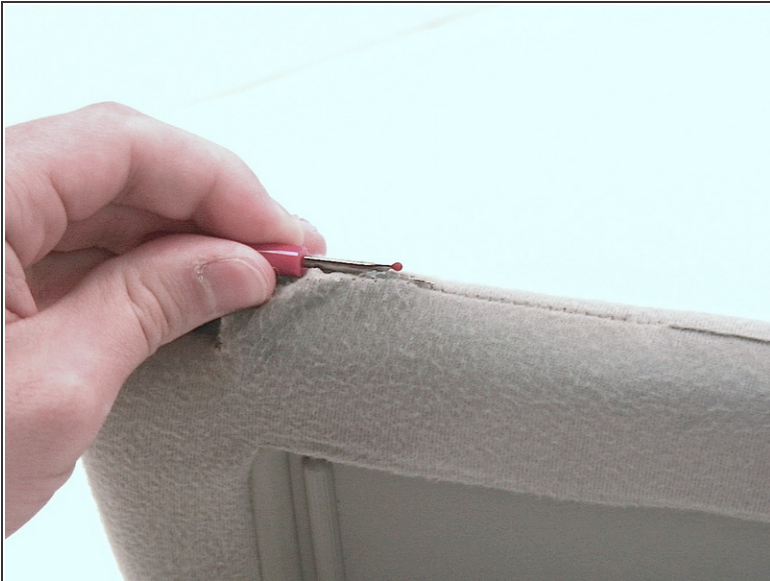
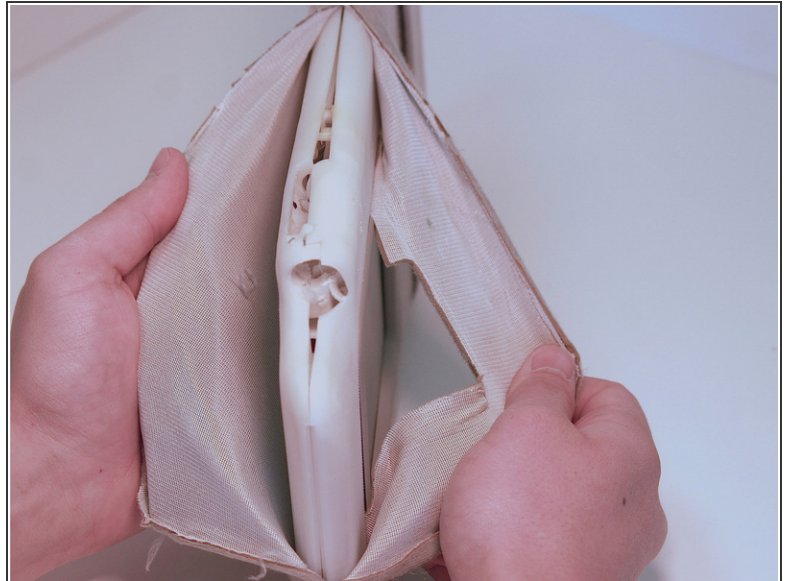
Step 2

- Tear open the seam surrounding the hole that the swing arm inserts into with a seam ripper.
- Pull the fabric back to show the inner casing.

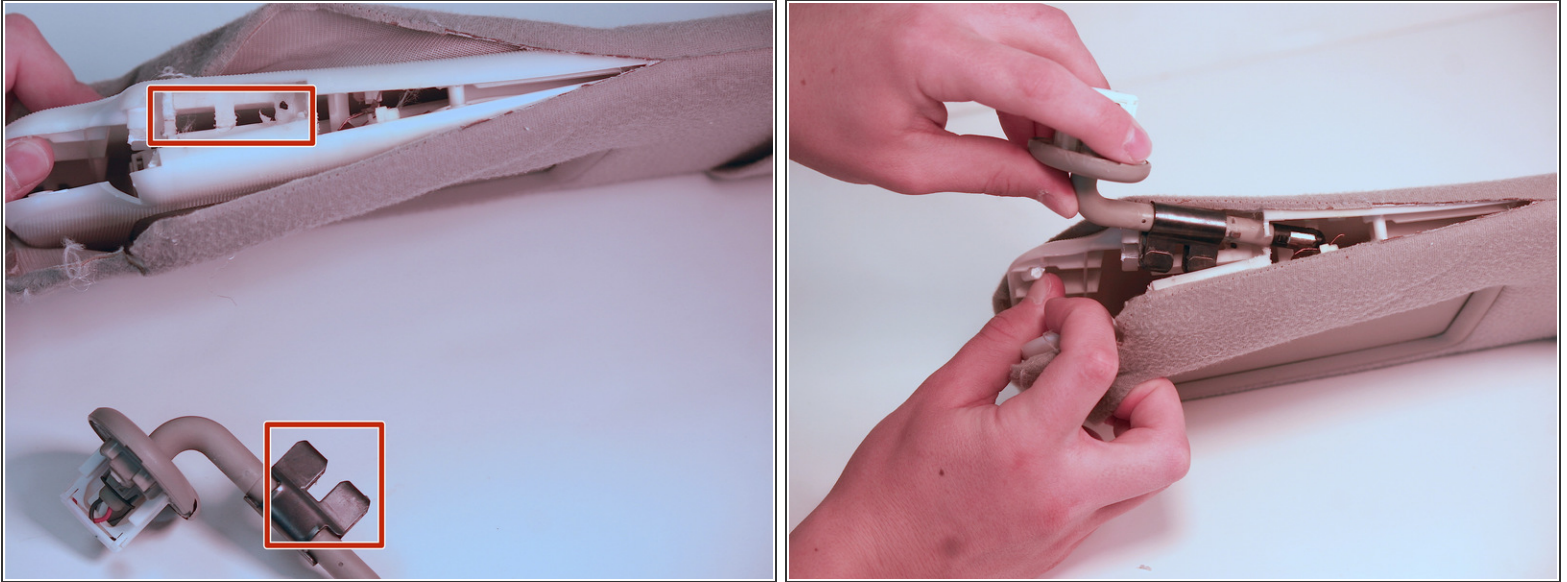
Step 3

- Reinsert the swing arm back into the visor, make sure the metal prongs on the swing arm line up with the holes on the visor.

i The red squares show where the metal prongs fit into the holes of the visor.

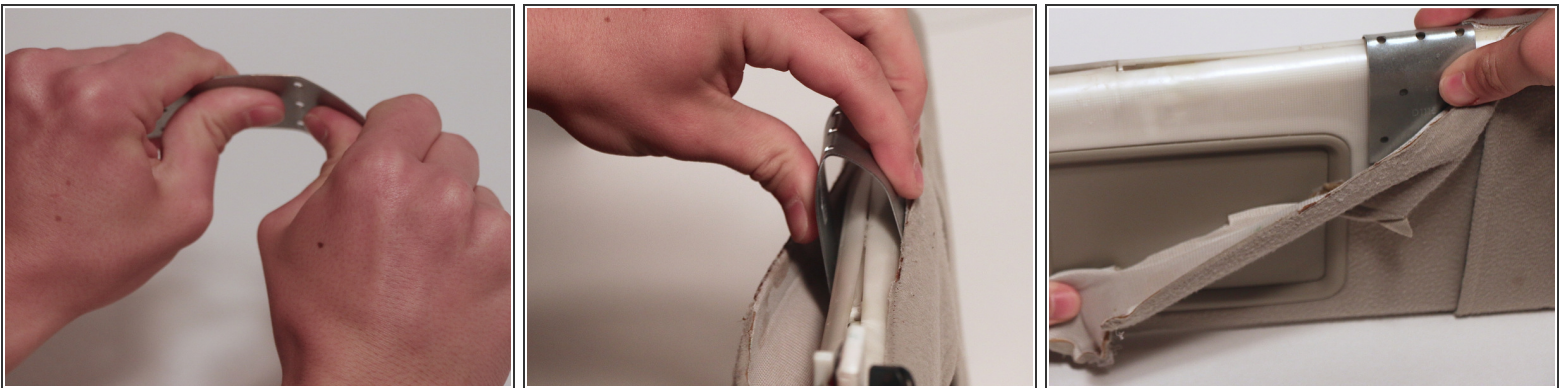
Step 4

- Fold the aluminum plate around the outer casing to reinforce the arm in the casing.

i The metal plate will hold both halves of the visor to the lever arm, so make sure it is secured tightly around visor to keep it together.

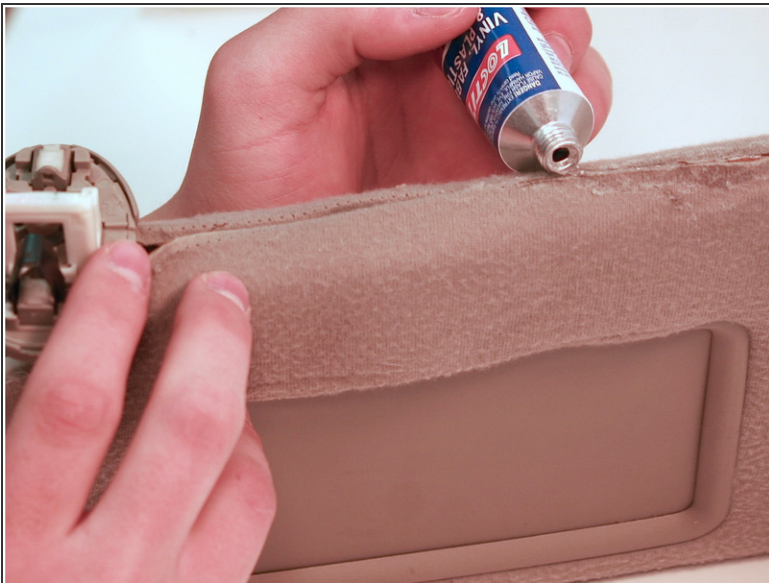
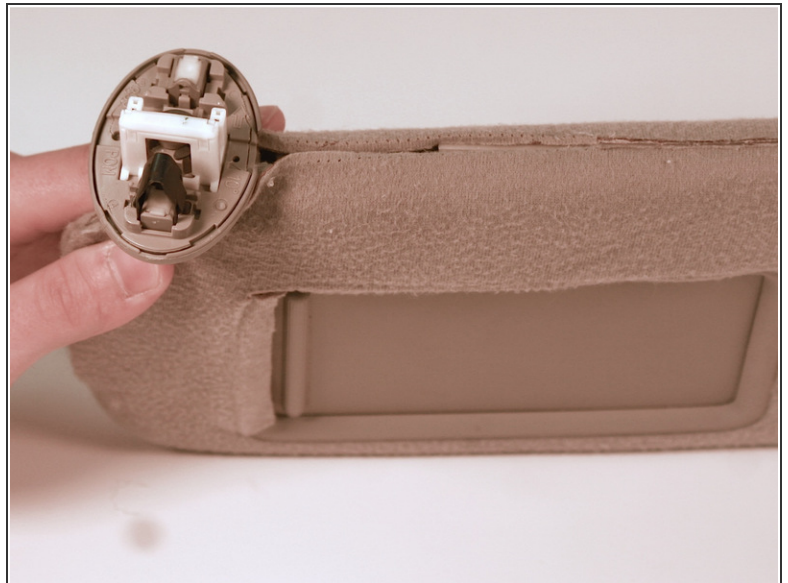
Step 6

- Adhere the two halves of the torn seam back together over the outer casing and the aluminum plate using upholstery glue.
- ⓘ Allow the glue to properly dry before replacing visor back into car.
